Manhole Inspection Summary

Manhole # S29G__008MH

Insp Date: **4/9/09 9:21 AM**

Location Address: **PENN ST**

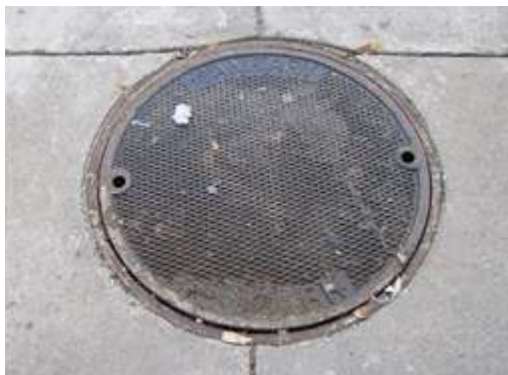
Miscellaneous

cover view

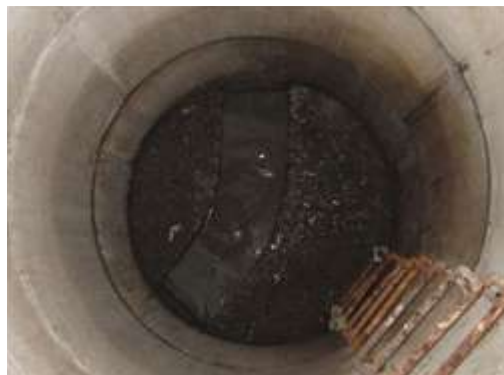
Defect 3

Steps Count: **14** Missing: **0** ☒ **Corroded**

corroded steps

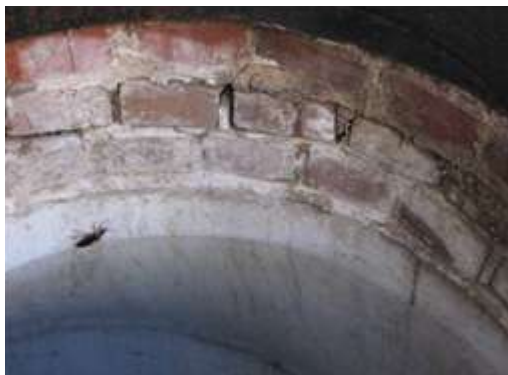
Defect 1

Condition: ☐ Sound ☐ Cracked ☐ Root Intrusion ☒ **Loose Brick** ☐ Deteriorated

Loose brick in chimney

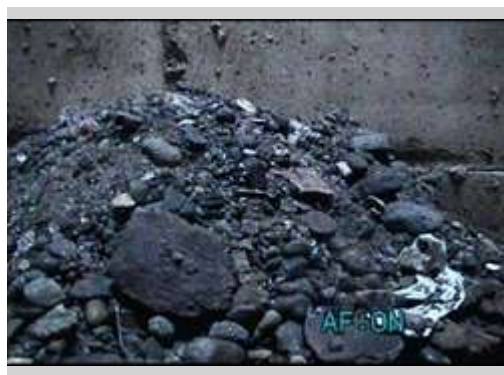
Defect 2

Condition: ☐ Sound ☐ Cracked ☐ Root Intrusion ☐ Deteriorated ☐ Leaks ☒ **Debris**

DEBRIS ON BENCH

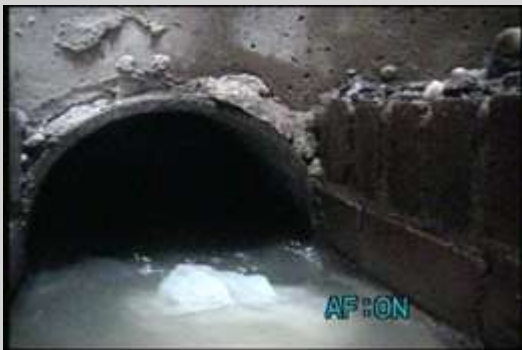
12 O'Clock Outflow

12 in. Circular Gravity Sewer
Pipe Out @ 12 O'Clock

Pipe Height: **12** (in.) Rod and Bar (Angled)
Pipe Material: **Clay** ☐ Pipe Lined
Invert Depth: **17.44** (ft.) Flow Characteristics: **Slow**
Deposits: ☐ None ☐ Mud ☐ Sludge ☒ **Debris** ☐ Grease
Silt Depth: **5** (in.) Deposits Extent: **Medium**
Infiltration: **None** Pipe Seal Cond: **Sound**

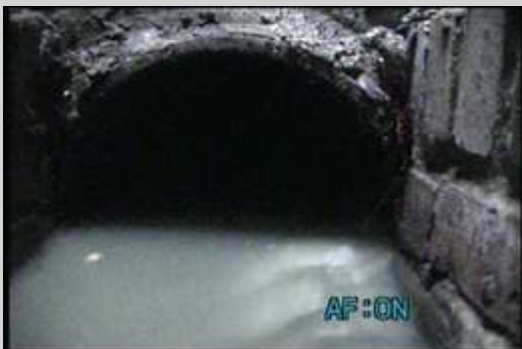
7 O'Clock Inflow

12 in. Circular Gravity Sewer
Pipe In @ 7 O'Clock

Pipe Height: **12** (in.) Rod and Bar (Angled)
Pipe Material: **Clay** ☐ Pipe Lined
Invert Depth: **17.28** (ft.) Flow Characteristics: **None**
Deposits: ☐ None ☐ Mud ☐ Sludge ☒ **Debris** ☐ Grease
Silt Depth: **4** (in.) Deposits Extent: **Medium**
Infiltration: **None** Pipe Seal Cond: **Sound**
